## Update “With Site-Visit” Reserve Study

### South Bay CA Port Ludlow, WA

**Report #:** 23316-0  
**For Period Beginning:** July 1, 2014  
**Expires:** June 30, 2015  
**Date Prepared:** May 7, 2014

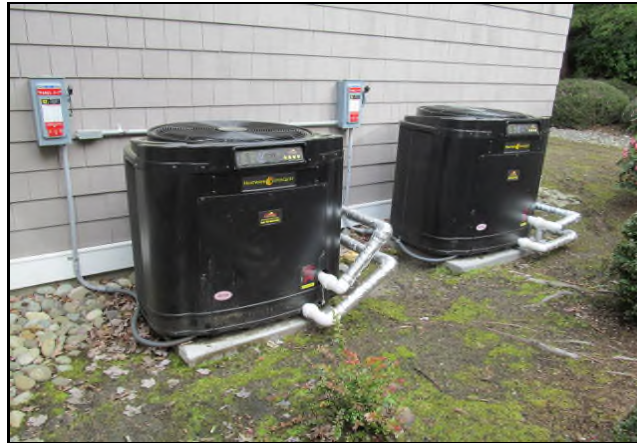
History : Heat pumps installed in 2012

Evaluation : Good condition with no reported problems at present (although thermostats were recently replaced under warranty). Electric heat pumps were installed in 2012 as part of ~\$18,000 efficiency improvement project and now provide primary heating of indoor pool and spa. Regular inspections, maintenance and repairs are assumed. Plan for typical replacement interval at roughly the time frame indicated below.

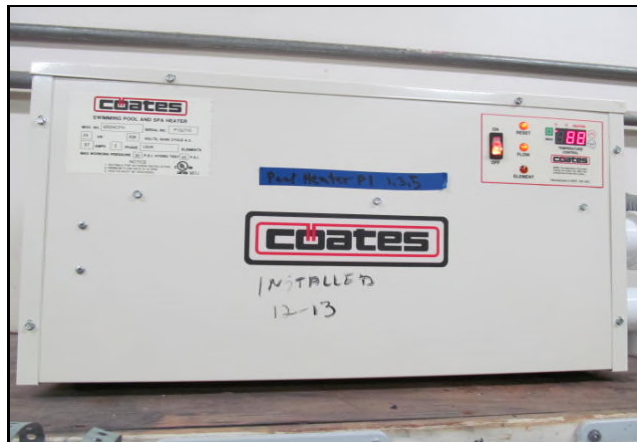
History : Replaced last in 2013

Evaluation : These electric heaters were both replaced last in 2013 and are now considered auxiliary heaters. Typically replacement interval of between the 5-10 year mark of life is projected below.

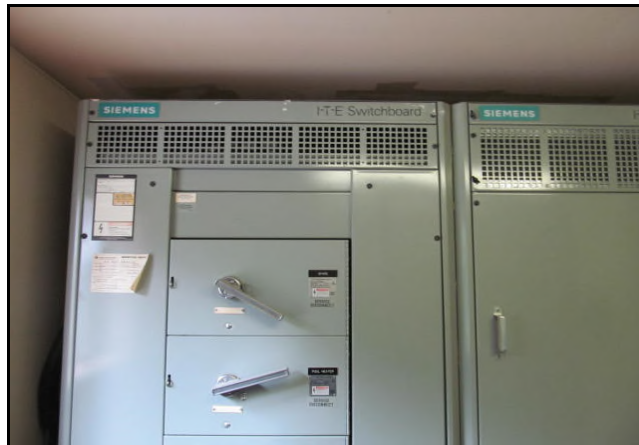
Evaluation : Assessing the electrical systems is also beyond the scope of our services. No significant problems reported at this time. If installed per architectural specifications and local building codes, there is no predictable time frame for large scale repair/replacement expenses within the scope of our report. Treat minor repairs as ongoing maintenance expense. We recommend routine inspections (including infrared or thermographic testing) to assess conditions on an ongoing basis, along with regular maintenance of cleaning, tightening connections, etc... Funding may be incorporated into future reserve study updates if conditions change. No reserve funding suggested at this time.

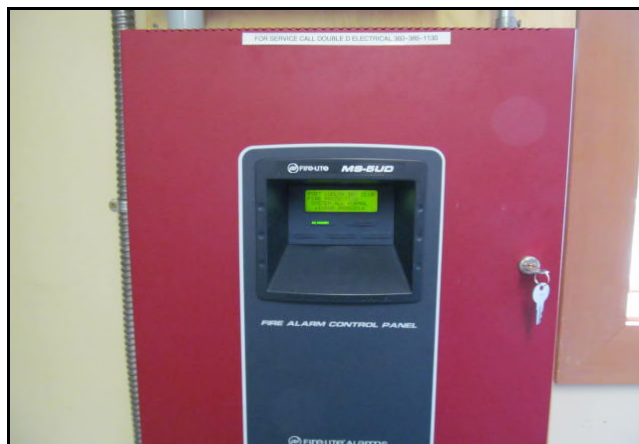
History : Replaced in 2012 at an expense of \$3,000.

Evaluation : It is our understanding that system was replaced in 2012 at an expense of \$3,000. Assumed to be operating as designed; professional inspections are recommended and indicated. Prudent planning suggests setting aside funding for periodic panel replacement to maintain functionality and offset parts obsolescence at the roughly the interval indicated below.

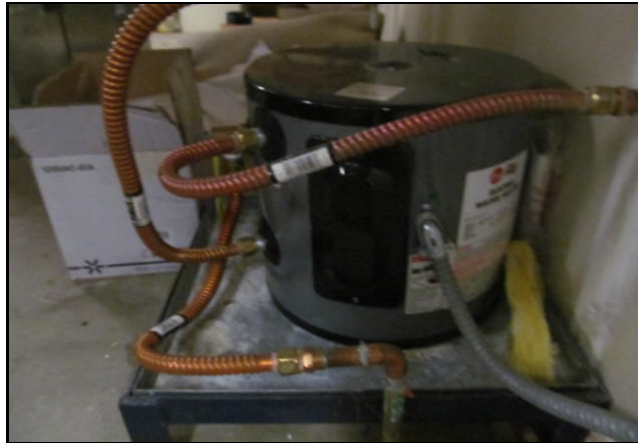
Evaluation : This component represents less costly water heaters. Newer Bradford White 50 gallon electric unit in pool/spa equipment room was replaced in 2013; no cost history was provided. Also, two smaller (6 and 10 gallon) units are apparently deployed. In any event, same recommendations regarding proactive replacements will apply here as well. Provide individual replacements (under \$2,000) as an operating expense.

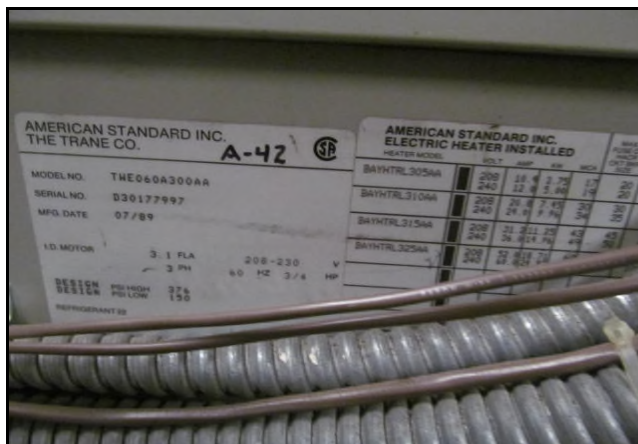
Evaluation : Older units with general deterioration but still functional at the moment. Equipment is already well beyond the typical 15-20 year service life expectation. No preliminary bids or proactive plans for next replacement to occur; anticipate replacement needs at anytime in the near future. We recommend regular professional maintenance and repairs. Plan for regular intervals of replacement at typical life expectancy indicated below. Note; consideration may be given to transition to more efficient heat pumps but we only factored like-kind replacement at this time. If electing upgrade, anticipate total project cost closer to \$150,000. Adjust in future reserve study updates as conditions merit.
