## Update "With-Site-Visit" Reserve Study

### South Bay Community Association Port Ludlow, WA

**Report #: 23316-1**  
**For Period Beginning: August 1, 2017**  
**Expires: June 30, 2018**

**Date Prepared: August 2, 2017**

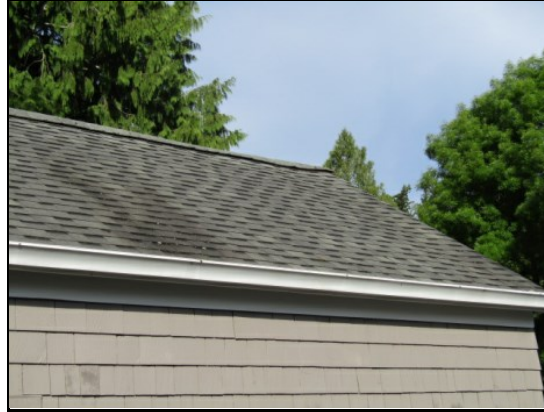
Evaluation: Only general deterioration as expected was noted from our grade level observation. No current problems or previous repair history was reported. We recommend professional inspections at least twice annually and after wind storms, promptly replacing damaged/missing shingles or any other repair as may be needed to ensure that the waterproof integrity of the building is maintained. Keep gutters and downspouts clear and free of debris to allow water to evacuate from rooftops as designed. Plan for roof replacement intervals at the 20-25 year mark of life as indicated below. Include small quantity of gutter/downspout within this component.

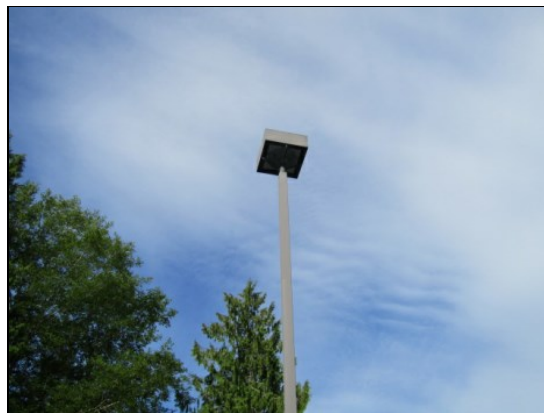
Evaluation: Generally fair condition. As routine maintenance, inspect, repair/change bulbs as needed. Anticipate eventual replacement of assemblies (poles, fixtures, wiring) at roughly the time frame below to ensure uniform functionality and contemporary appearance.

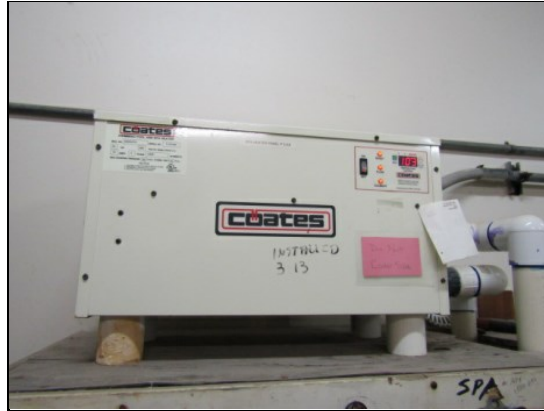
Evaluation: Spa electric heater was replaced last in 2012 and is now considered auxiliary heater. Typical replacement interval of between the 5-10 year mark of life is projected below.

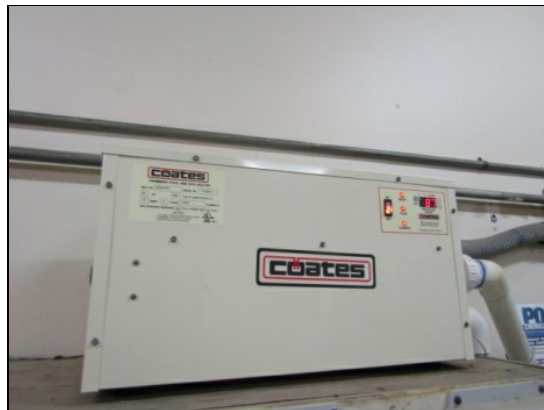
Evaluation: Pool electric heater was replaced last in FY 2016 at reported expense of only \$2,200. Typical replacement interval of between the 5-10 year mark of life is projected below.

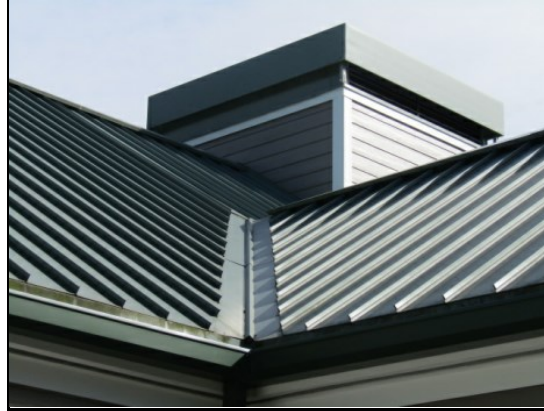
Evaluation: As already mentioned, one-time roof repair is planned for FY 2017/2018. Expense of roughly \$13,200 is assumed to remedy roof leaks at some valleys.

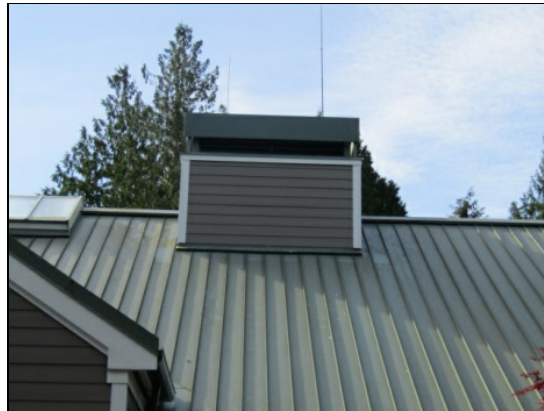
Evaluation: In addition to one-time repairs already factored for FY 2017/2018, your further needs/plans for preventative maintenance to occur every five years. Cyclical reserve funding is factored going forward with input from Management.

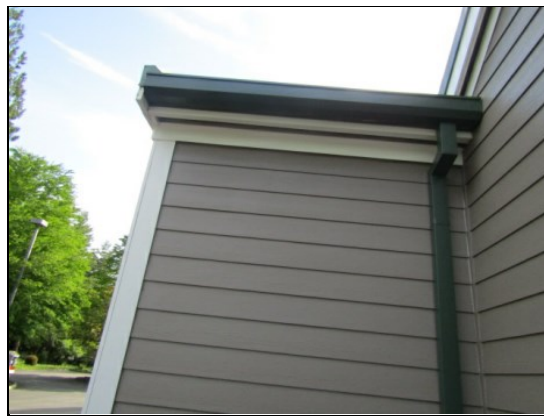
Evaluation: Replacement of Clubhouse gutters and downspouts was reportedly part of FY 2016/2017 exterior repairs. Segregated expense was apparently \$22,000 but likely included improvements for drainage as opposed to simple replacement. Inspect regularly, keep free of debris to ensure water evacuating from rooftops as designed and repair as needed from general operating funds. Best to plan for replacement to ensure appearance and performance.

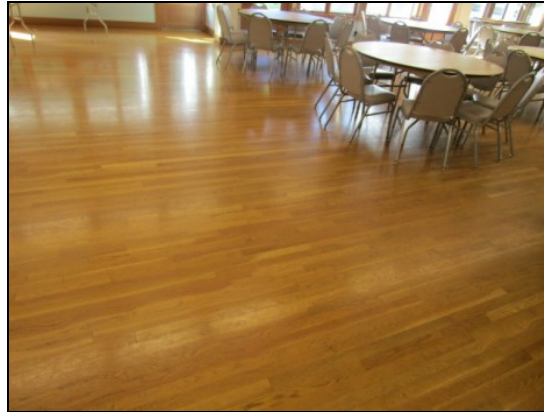
Evaluation: Majority with general deterioration and fading. Auditorium wood floor was reportedly refinished last in 2004 at an expense of ~\$12,000; small stage has apparently been refinished since our 2014 site inspection. No current plans for large scale FY 2017/2018 project. Anticipate future intervals of professional resurfacing of wood as factored below. If needed, more frequent refinishing of stage should be provided in between from operating funds.

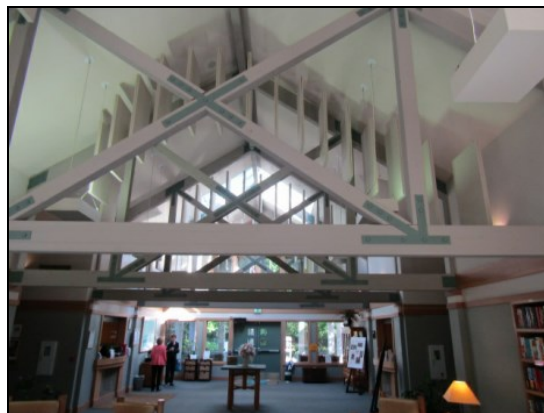
Evaluation: Condition varies to some degree but general deterioration and fading for most areas with large scale painting project perhaps occurring last in 2007; definitive timeline or cost history was not provided. Smaller projects, such as exercise room was painted in FY 2013 and conference room in 2011. Going forward, regular cycles of uniform painting and refinishing of interior wood work are recommended to maintain quality appearance; typical useful life cycles are 8-12 years. Time projects prior to flooring replacement or refinishing for maximum aesthetic impact, logistics and cost efficiencies. Keep touch-up paint on site for in between cycle projects.

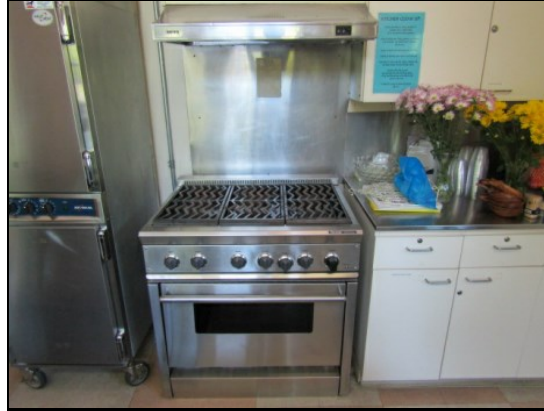
Evaluation: Thermador six-burner gas oven was reportedly installed last in either 2002 or 2010; current working assumption is that equipment is more likely older. Anticipate needs every 8-15 years as factored below.

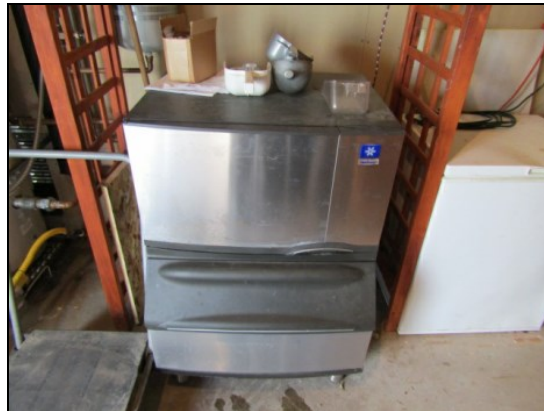
Evaluation: Unit reportedly purchased in 2005 (we assume as new equipment). For purposes of long term planning, anticipate replacement every 12-15 years as factored below.

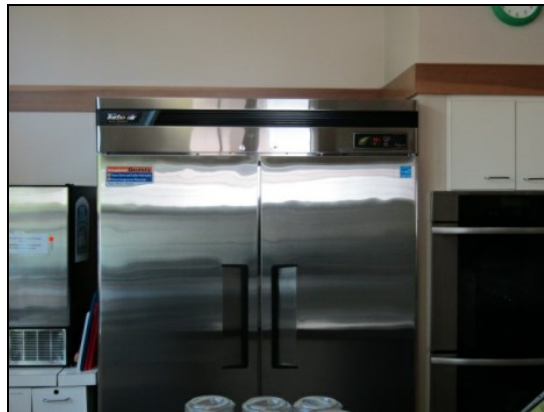
Note that previous Hobart refrigerator was replaced in 2010. Regardless, anticipate needs at more conventional 8-10 years as factored below.
