## Update "With-Site-Visit" Reserve Study

### **South Bay Community Association Port Ludlow, WA**

**Report #: 23316-2**

**Date Prepared: December 1, 2020**

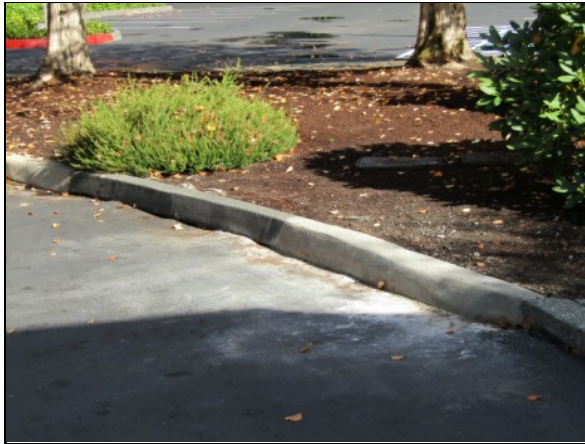
Comments: Assorted concrete surfaces and curbing are in generally fair condition but some areas with local cracking, damage and prior repair were noted with poor aesthetic at targeted locations. Previous expense history includes at least FY 2020/2021 YTD curb repair at \$3,500 expense, \$2,600 for 2013 sidewalk repair and another \$2,400 for curb repair in 2011. Also, another project where previous small addition of concrete between the kitchen and storage building was noted (cost unknown). Further, your plans for ADA improvements for concrete located near main entrance in FY 2021/2022 at expense of \$5,000 were indicated. Going forward, assume local repair/replacement allowance below as a cyclical reserve component. Ensure that repair of any trip and fall hazards takes place immediately to help provide for safety.

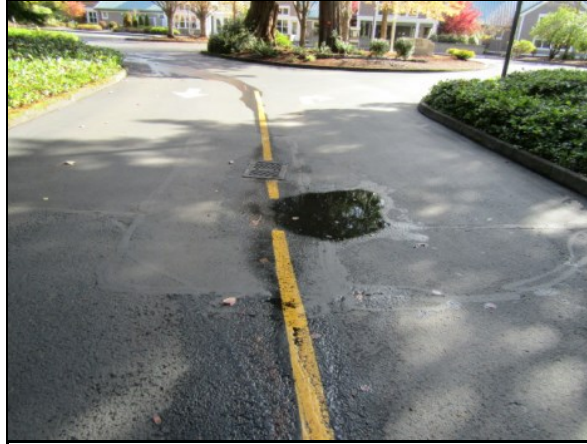
Comments: As compared to our previous 2017 site inspection, somewhat improved appearance of asphalt surface was illustrated due to recent maintenance. Research indicated previous history of asphalt projects includes; FY 2020/2021 YTD project expense of \$24,000 for crack fill, one small patch, seal coating and stripe/painting, FY 2015 partial seal \$5,900, FY 2014 partial repair/replace \$24,600, FY 2010 patch and repair \$6,120 and stripe \$1,184. We note the small pot hole in image below was repaired in FY 2020/2021 but has since failed and we assume will be repaired again by contractor at no charge. Also, it appears more local areas of repair were possible but apparently deferred. In any event, timely cycles for seal coating (every 4-5 years) of all asphalt surfaces along with any needed repair has proven to be the best program in our opinion for the long term care of asphalt. Seal coating provides limited benefits against damaging weather elements while bridging small surface cracks and providing uniform appearance over the inevitable patching and repairs needed over time. Incorporate any restriping, paint to coincide with this project. Fill cracks and clean oil stains promptly in between cycles.

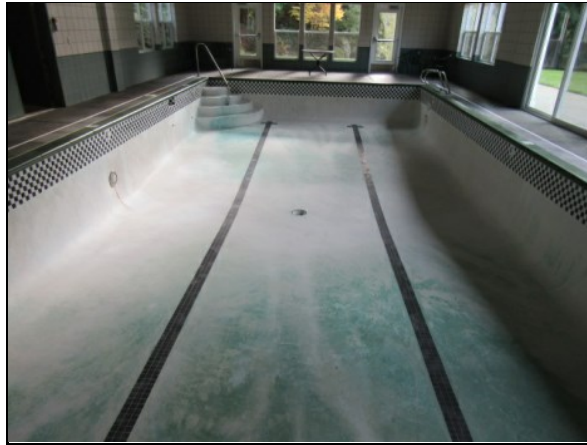
Comments: Pool was closed, water drained when we inspected in 2020 during global pandemic; deterioration, fading of plaster noted. Your plans for FY 2020/2021 \$23,200 pool project to replaster, add bull nose tile to steps and replace existing race line tiles. Fill tiles, other decorative tile at steps apparently not getting replaced during that project. Previously the pool and spa were resurfaced in FY 2013/2014 at a combined expense of ~\$27,000 so only seven years useful life achieved for existing pool plaster. Further in past, pool resurface project reportedly occurred in 2003. In addition to timely cleaning and maintenance, plan for regular intervals of pool resurfacing every seven to ten years to maintain a quality appearance.

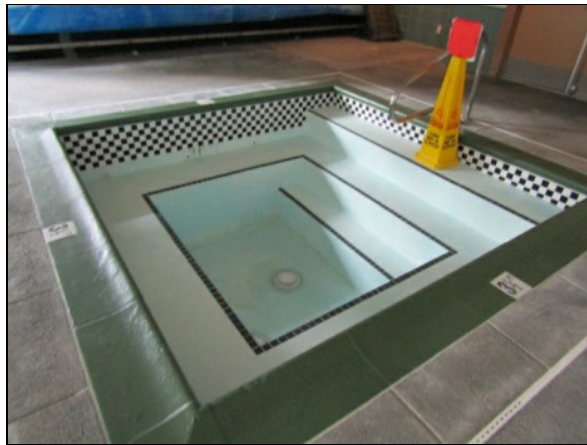
Comments: Spa was closed, water drained when we inspected in 2020 during global pandemic; good appearance. FY 2018/2019 spa resurface project at expense of \$5,800 apparently included transition of previous tile at seating areas to plaster. Best to plan for more frequent resurfacing intervals of spa as compared to pool due to higher temperatures and chemical concentrations. Inspect regularly and ensure compliance with VGBA to provide safety.

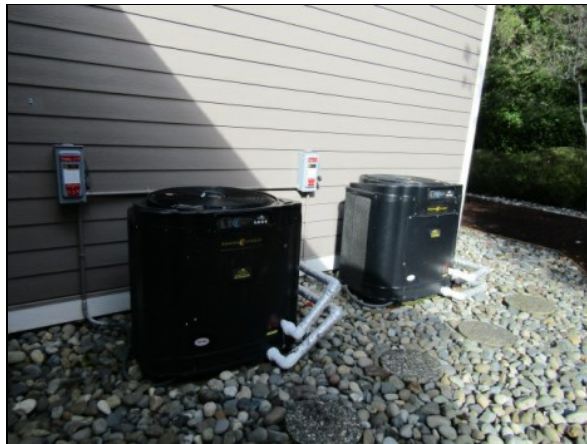
Comments: Electric heat pumps were installed in 2012 as part of ~\$18,000 efficiency improvement project, providing primary heating of indoor pool and spa. Fair condition with no reported problems at present. FY 2019/2020 \$1,800 minor expense for spa heat pump repairs. Also, thermostats were previously replaced under warranty. Regular inspections, maintenance and repairs are assumed. Plan for typical replacement interval at roughly the time frame indicated below.

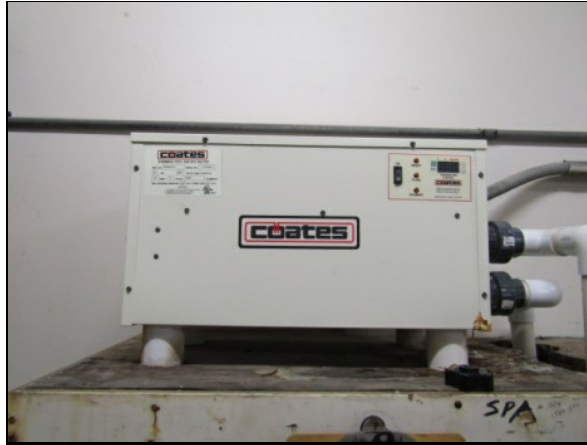
Comments: Spa electric heater was replaced last in FY 2017/2018 at an expense of only \$2,040. Previously replaced in 2012 but is now considered an auxiliary heater. Typical replacement interval of between the 5-10 year mark of life is projected below.

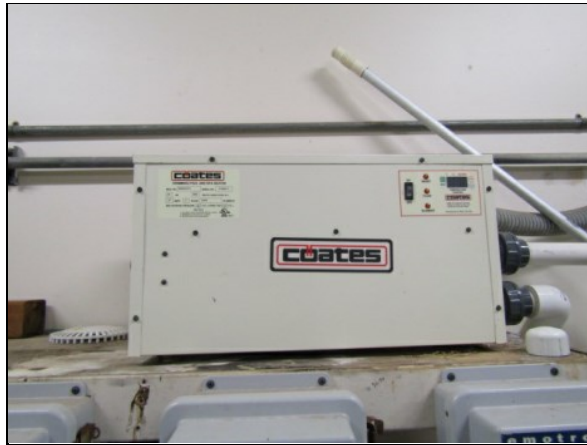
Comments: Pool electric heater was replaced last in FY 2016 at reported expense of only \$2,200. Previously replaced in 2013 but is now considered an auxiliary heater. Typical replacement interval of between the 5-10 year mark of life is projected below.

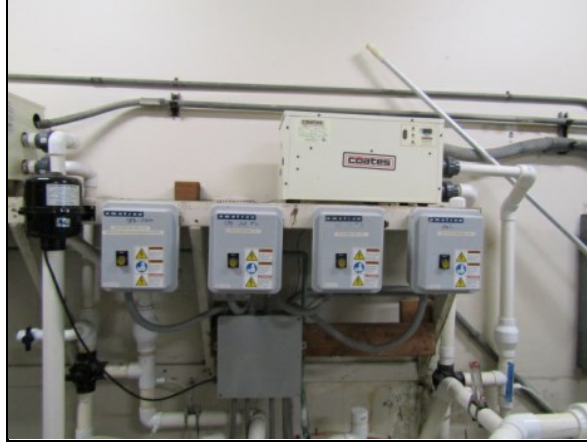
Comments: No reported problems with automatic pump shut-off controls (anti-entrapment). Replacement was included in expense of ~\$6,300 in 2012 project to comply with VGBSA. Anticipate integrated replacement needs to maintain contemporary functionality in the future.

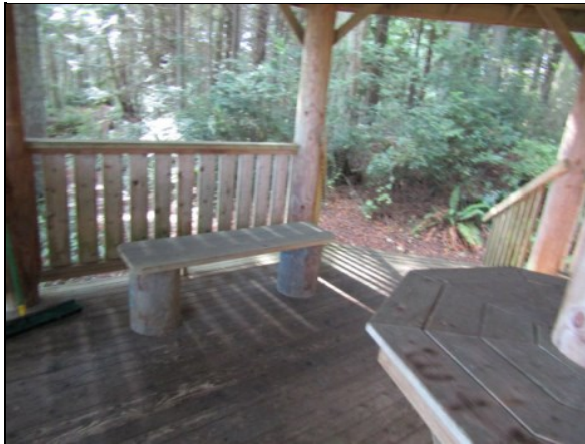
Comments: Fair, stable condition for this substantial construction. Wood deck was reportedly replaced in 2011 and entry stairs in 2013 (by on-site staff). No anticipation of total replacement needs; some allowance for partial repair/replacement continues to be factored below. Continue to treat smaller expenses to clean, stain or provide spot repairs as operating expense (see next component regarding roof shingles). Carefully track and adjust as usage, actual expense patterns continue to develop.

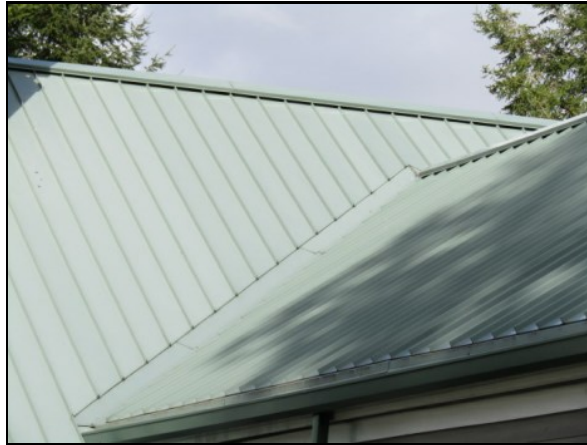
Comments: Your ongoing needs/plans for preventative maintenance, sealing of metal roof to occur every two years. Last event in FY 2019/2020 at expense of \$4,300; cyclical reserve funding allowance continues to be factored going forward.

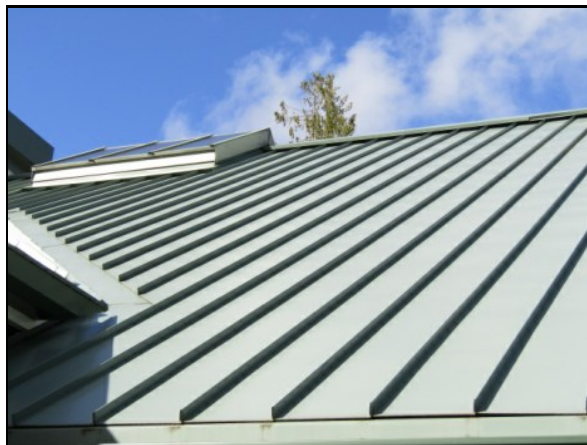
Comments: Significant historical expense to clean metal roof in recent years. Last event was FY 2018/2019 at reported expense of \$9,300. Prior to that FY 2015/2016 at cost of \$5,900. Cyclical reserve funding is factored going forward with input from Management.
