## Update “With Site-Visit” Reserve Study

### South Bay CA Port Ludlow, WA

**Report #:** 23316-0  
**For Period Beginning:** July 1, 2014  
**Expires:** June 30, 2015  
**Date Prepared:** May 7, 2014

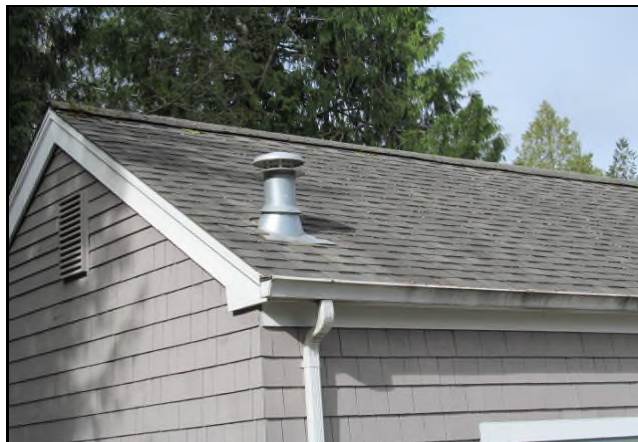
| # | Component | Quantity | Useful<br>Life | Rem.<br>Useful<br>Life | [ --- Current Cost Estimate --- ] | |
|---|---|---|---|---|---|---|
| 252 | Storage Building Roof - Replace | Approx 615 square feet | 25 | 5 | \$2,740 | \$3,180 |

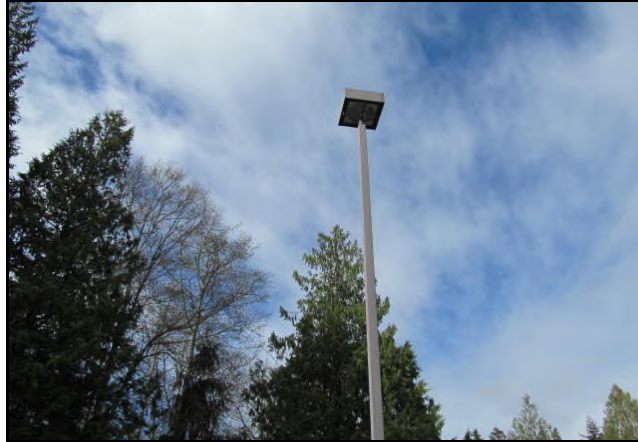
| # | Component | Quantity | Useful<br>Life | Rem.<br>Useful<br>Life | [ --- Current Cost Estimate --- ] | |
|---|---|---|---|---|---|---|
| 270 | Pole Lights - Replace | (11) metal | 40 | 15 | \$30,800 | \$35,200 |

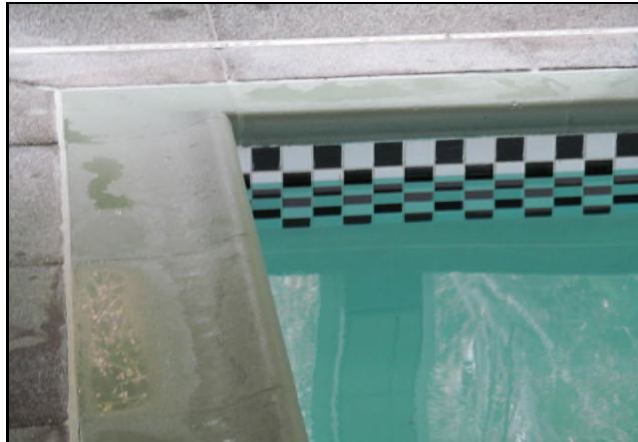
| # | Component | Quantity | Useful<br>Life | Rem.<br>Useful<br>Life | [ --- Current Cost Estimate --- ] | |
|---|---|---|---|---|---|---|
| 404 | Pool/Spa Tile/Coping - Replace | Approx 160 linear feet | 20 | 9 | \$12,800 | \$19,200 |

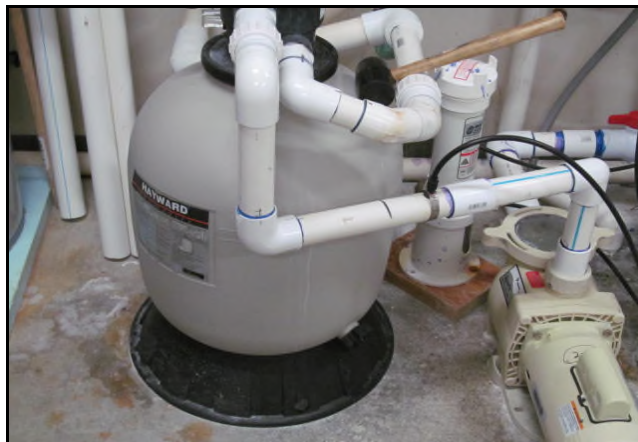
| # | Component | Quantity | Useful<br>Life | Rem.<br>Useful<br>Life | [ --- Current Cost Estimate --- ] | |
|---|---|---|---|---|---|---|
| 410 | Pool/Spa Filters - Replace | (2) assorted, media | 20 | 15 | \$3,200 | \$4,000 |

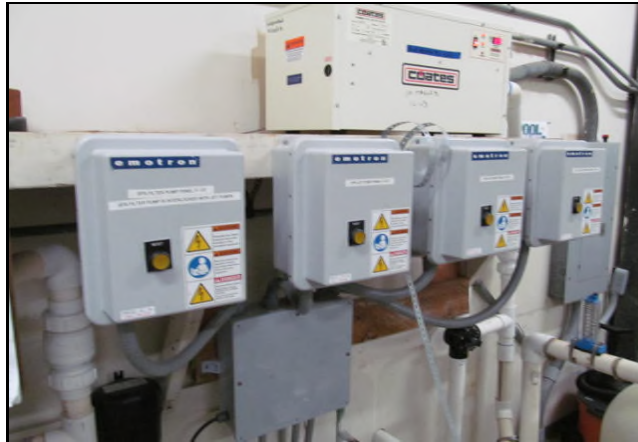
| # | Component | Quantity | Useful<br>Life | Rem.<br>Useful<br>Life | [ --- Current Cost Estimate --- ] | |
|---|---|---|---|---|---|---|
| 414 | Pool/Spa Pump Controls - Replace | (4) Emotron PSP20 | 10 | 8 | \$3,200 | \$4,800 |

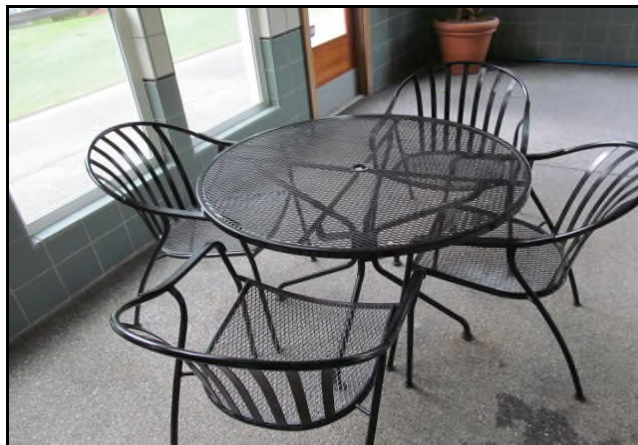
| # | Component | Quantity | Useful<br>Life | Rem.<br>Useful<br>Life | [ --- Current Cost Estimate --- ] | |
|---|---|---|---|---|---|---|
| 420 | Pool Furniture - Replace | (10) assorted | 10 | 5 | \$2,000 | \$3,000 |

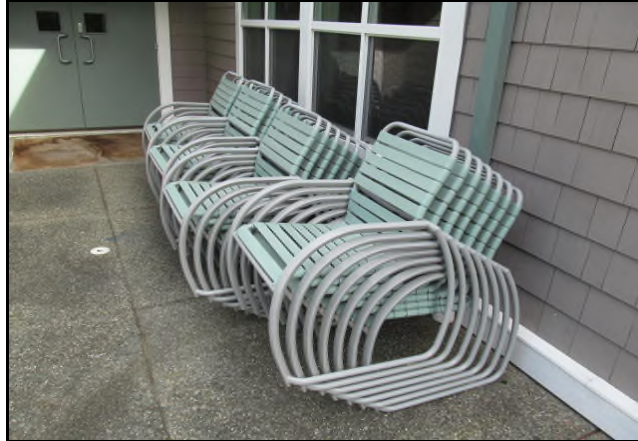
| # | Component | Quantity | Useful<br>Life | Rem.<br>Useful<br>Life | [ --- Current Cost Estimate --- ] | |
|---|---|---|---|---|---|---|
| 430 | Patio Furniture - Replace | (30) assorted | 10 | 7 | \$12,000 | \$16,000 |

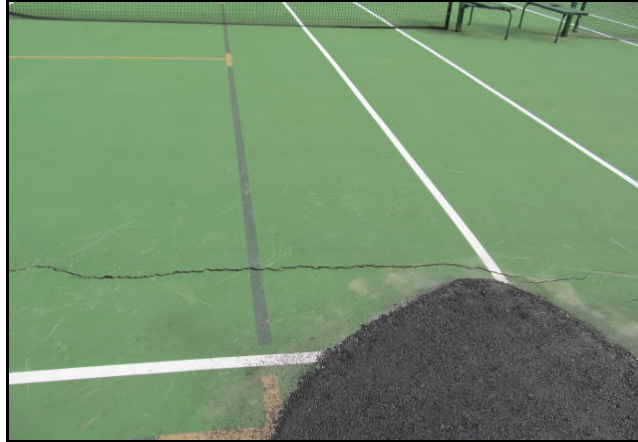
**Comp # : 450 Tennis Courts - Repair/Top Coat**

Evaluation : Note; SBCA is not owner of these tennis courts but rather has a long term lease. Your Association is reportedly entirely responsible for amenity maintenance expenses. Generally poor appearance with surface fading and deterioration along with local cracking, damage and recent repair noted. Imminent plans for completion of repair and acrylic surface treatment (top coat) project to occur in FY 2013/2014 at projected expense of \$21,000. Provided information regarding previous projects included; prior RDA reserve study indicated 2009 "resurface" and your FY 2012 depreciation schedule indicates "tennis court improvements" of \$14,500 in 2003. In any event, plan for similar future maintenance projects for repair and top coat roughly every 6-8 years. Keep clean as part of routine maintenance.

Lower estimate to clean, spot repair and top coat

Higher estimate to clean, spot repair and top coat

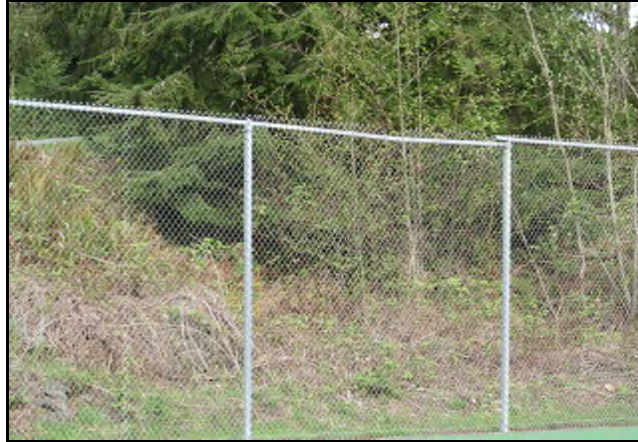
**Comp # : 456      Tennis Court Fence - Replace      Quantity: Approx 560 linear feet**

Evaluation : A disjointed connection but otherwise generally fair condition with no significant corrosion or instability noted at this time. Sturdy component that can last for extended period of time if not damaged or abused. Clean, repair as needed from operating funds. Expectation for long term replacement needs, so reserve funding factored below.

Lower estimate to replace

Higher estimate to replace

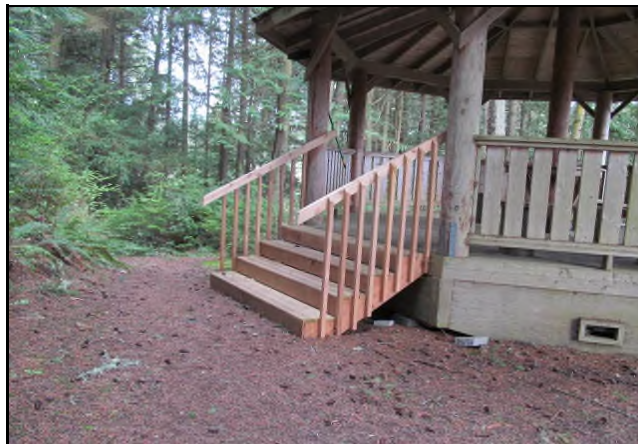
**Comp # : 460      Gazebo Structure - Maintain/Repair      Quantity: (1) wood, large**

Evaluation : Fair, stable condition for this substantial construction. Entry stairs were recently replaced (2013) by on-site staff. Research with Management indicated ongoing minor projects to clean, stain, or repair will continue to be treated as operating expense (see next component regarding roof shingles). No anticipation of total replacement needs for the foreseeable future with ordinary care and maintenance.

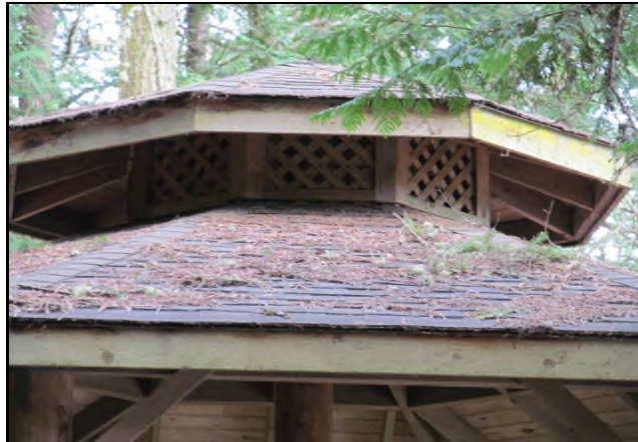
**Comp # : 462 Gazebo Roof - Replace**

History : Replaced last in 2011 at expense of \$2,000.

Evaluation : Good condition where observed; roof was reportedly replaced last in 2011 at expense of \$2,000. Needs for routine roof cleaning were evident; anticipate frequent maintenance in this heavily treed location to achieve typical useful life of 20-25 years.

Lower estimate to replace with similar

Higher estimate to replace with similar

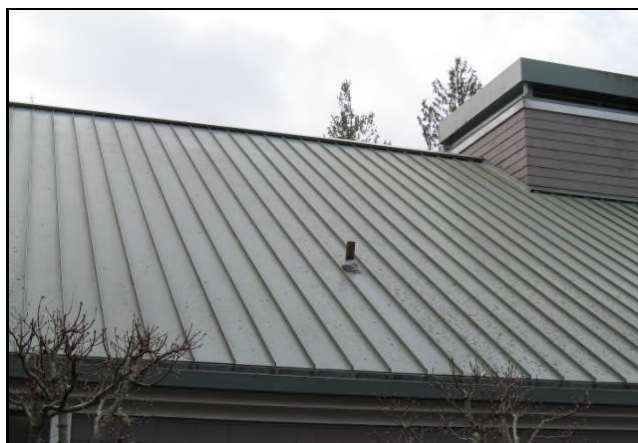
**Comp # : 504 Bay Club Roof - Replace**

Evaluation : Durable metal roof without advanced deterioration noted during our limited scope visual inspection. Some local repair was reportedly needed in recent years due to water infiltration (primarily transition flashing issues). As routine maintenance, we recommend professional inspections at least twice annually and after wind storms, promptly repairing as may be needed to ensure that the water proof integrity of the buildings is maintained. Regular cleaning regimen is also important to sustain and provide for quality appearance. Typical useful life of either similar metal roofing (and the underlying water proof membrane) or alternately a quality dimensional shingle in this application is 35-45 years. As project draws near, consider future replacement with a quality dimensional shingle for cost efficiency and ease of maintenance/repair.

Lower estimate to replace with similar metal roof

Higher estimate to replace with similar metal roof

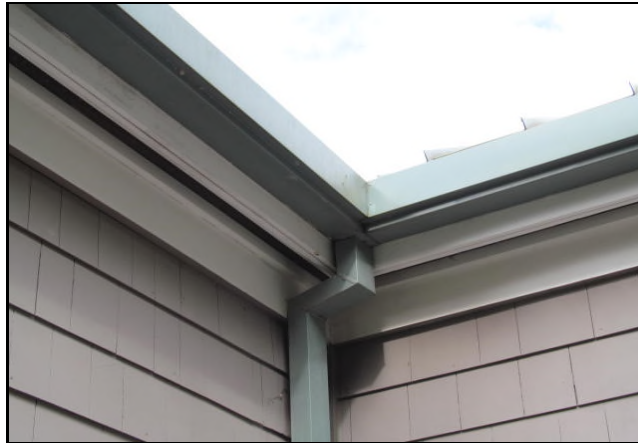
**Comp # : 510 Bay Club Gutters/Downspouts-Replace** Quantity: Approx 950 linear feet

Evaluation : Fair condition with no significant damage or instability observed at this time. Inspect regularly, keep gutters and downspouts free of debris to ensure water evacuating from rooftops as designed and repair as needed from general operating funds. Best to plan for eventual replacement at the same interval as roof replacement to ensure best appearance and performance.

Lower estimate to replace

Higher estimate to replace

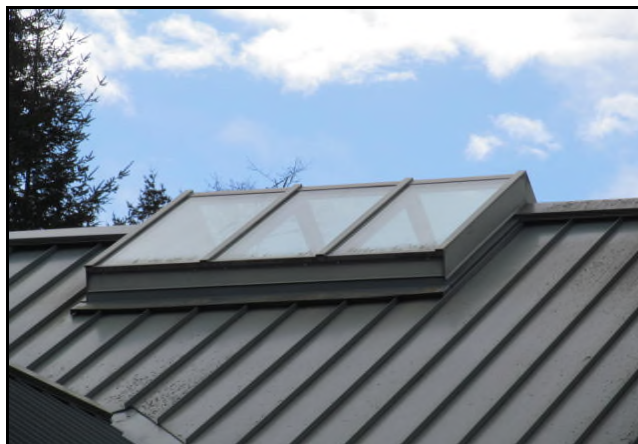
**Comp # : 515 Skylights - Replace** Quantity: (8) large, assorted

Evaluation : No problems nor previous pattern of replacement expense reported for these large skylights. No significant damage or fogging noted from our grade level observations. Inspect regularly, repair promptly as needed to maintain water proof integrity of building. We suggest planning for replacement at least every roof replacement cycle to ensure quality construction, waterproofing and cost efficiency. Track needs, expense patterns and adjust in future reserve study updates as conditions warrant.

Lower estimate to replace

Higher estimate to replace

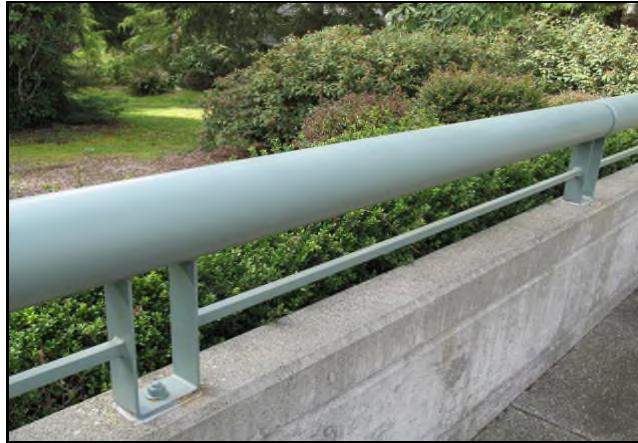
**Comp # : 524      Site Metal Rail - Replace**  
 Location : Rear patio, Southwest  
 Funded? : No Useful life not predictable or extended  
 History :

Evaluation : Fair condition without significant corrosion, damage or deterioration observed. Sturdy construction that can last for very extended period with ordinary care and maintenance. Inspect regularly for stability and tighten connections, repair promptly as needed to ensure safety. Clean periodically for appearance and paint along with other exterior building surfaces, no need for separate funding. No expectation of large scale replacement within the scope of this reserve study, therefore no reserve funding recommended.

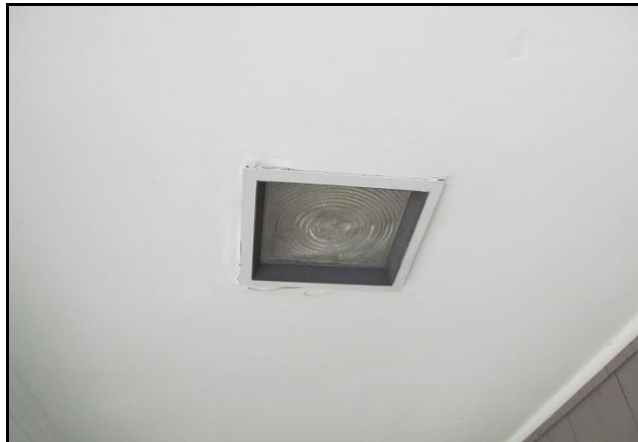
**Comp # : 530      Exterior Building Lights - Replace**  
 Location : Exterior building  
 Funded? : No Annual cost best handled as operating expense  
 History :

Evaluation : Assorted ages, conditions and types of fixtures with varying exposure to weathering elements. Observed during daylight hours; all are assumed to be in functional operating condition. Going forward, evaluate this modest quantity annually and replace individually or in small groupings from operating budget to help ensure a quality appearance.

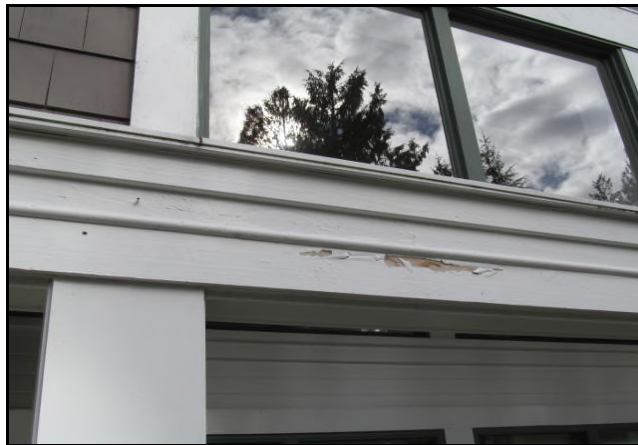
Evaluation : Fair to poor condition with general deterioration and fading of fields along with local areas of dryness and peeling evident at trim when we inspected on 4.8.2014. Previous RDA reserve study indicated painted last in 2009 at an expense of \$17,000, however, our research confirmed only 2006 paint project at expense of \$9,100 "plus supplies"; no further specifications were provided. Preliminary plans to paint only trim in FY2013/2014 at an expense of \$14,000. Going forward, we recommend cleaning and refinishing intervals to include all exterior building painted surfaces as appropriate for purposes of long term planning. This approach will ensure cost efficiency, best appearance and weather proofing performance. We also recommend regular professional inspections with prompt repair and touch- up as needed to ensure that material protection and water proof integrity of the building is maintained. Typical Northwest paint cycles, in a marine environment, are between four to seven years depending upon surface preparation, material quality, application methods, site and weather conditions. Maintenance of caulking with high quality product is important part of surface preparation. Repair any siding/trim necessary prior to painting. Anticipate cleaning, sealing and painting utilizing quality materials and workmanship at level indicated below.

Lower estimate to clean, seal and repaint exterior, plus  
\$6,000 minor siding/trim repair allowance

Higher estimate to clean, seal and repaint exterior,  
plus \$8,000 minor siding/trim repair allowance
