## Update "With-Site-Visit" Reserve Study

### South Bay Community Association Port Ludlow, WA

**Report #: 23316-1**  
**For Period Beginning: August 1, 2017**  
**Expires: June 30, 2018**

**Date Prepared: August 2, 2017**

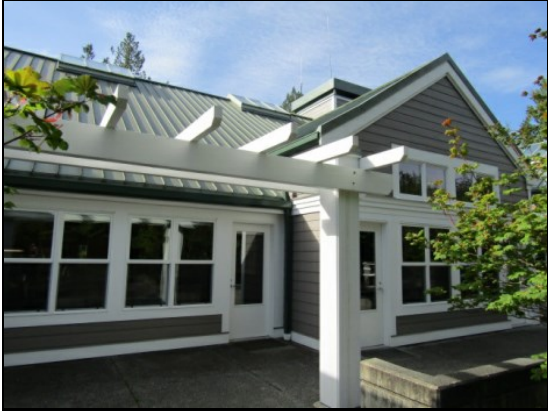
Evaluation: Much improved since our previous 2014 site visit; good condition with ample coverage noted. Exterior painting was evidently part of FY 2016/2017 ~\$835,000 repairs. Segregated expense was reportedly \$48,000. Going forward, we recommend cleaning and refinishing intervals to include all exterior building painted surfaces as appropriate for purposes of long term planning. This approach will ensure cost efficiency, best appearance and weatherproofing performance. We also recommend regular professional inspections with prompt repair and touch- up as needed to ensure that material protection and waterproof integrity of the building is maintained. Typical Northwest paint cycles are between five to ten years depending upon surface preparation, material quality, application methods, site and weather conditions. Maintenance of caulking with high quality product is important part of surface preparation. Repair any siding/trim necessary prior to painting. Anticipate cleaning, sealing and painting utilizing quality materials and workmanship at level indicated below.

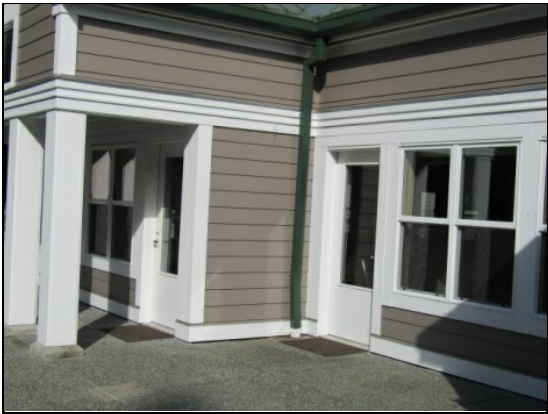
**Comp #: 542 Exterior Siding - Repair/Replace**

Evaluation: As new condition for Clubhouse exterior cladding (siding); now primarily consisting of cement fiber products.

Replacement was part of FY 2016/2017 ~\$835,000 repairs; we assume proper installation with adequate underlying moisture barrier. Small amount of older wood shingle and assorted trim at Storage Building is still in fair, stable condition. When correctly installed, siding is a durable, long lived product assuming proper care and maintenance (timely cleaning, caulking and refinishing).

We recommend regular professional inspections with prompt repair as needed to ensure weather tightness is maintained. For purposes of long term planning, we assume eventual replacement of siding, underlying weatherproofing at roughly 40 years as factored below. Such project is timed to coincide with future clean/paint/seal interval for cost efficiency and quality waterproofing.

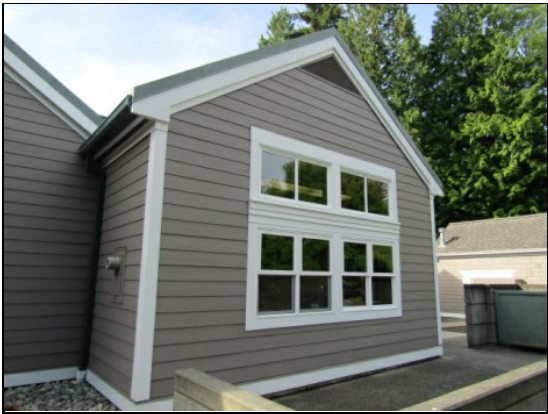
**Comp #: 544 Windows/SGD's - Replace**

Evaluation: Vast majority are newer; replacement was part of FY 2016/2017 ~\$835,000 repairs. If properly installed without defect, most windows and glass doors have a service life of 20 to 30 years or more. We recommend the Board provide for regular professional inspections of windows and glass doors, penetrations, sealants and adjacent structure by a highly qualified contractor or engineer to assess repair needs and timing to help prevent structural damage to building. Going forward, prudent planning suggests anticipation for eventual window replacement (glass, frames, etc..) during siding replacement project for quality weatherproofing. Adjust funding assumptions in future reserve study updates as conditions dictate (i.e. if patterns of significant and/or more urgent replacement needs become apparent). Carefully track needs and any actual expense patterns to facilitate accurate budget forecasting.

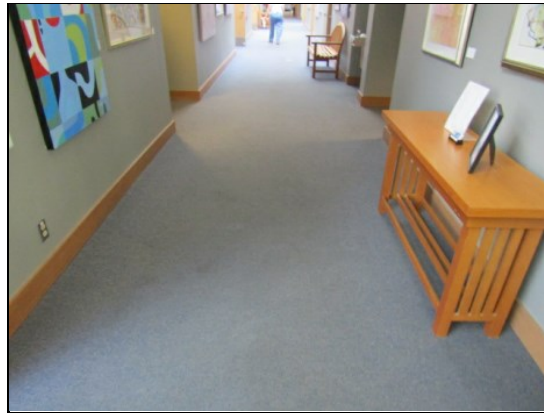
**Comp #: 600 Carpet/Vinyl - Replace****Quantity: Approx 1,200 SY**

Evaluation: Vast majority of interior flooring is older carpeting with some general aging, fading and wear but clean condition and without damage. Research indicated last large scale replacement has not occurred since 2004 or perhaps earlier. A few subsequent and minor local replacements were noted, such as conference room in 2010. As part of ongoing maintenance program, continue to vacuum carpet and clean as needed. Community benefits from proactive care and gentle use. Timing and expense are somewhat subjective by nature but periodic needs for aesthetic updating are not. No specific near term plans were expressed. For purposes of long term planning and to maintain a quality appearance, we recommend planning for replacement at roughly the 10-12 year time frame below.

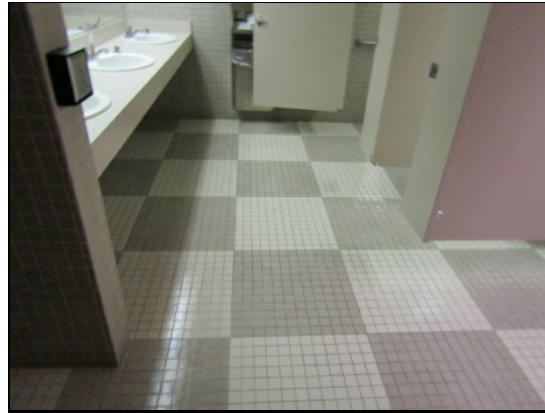
**Comp #: 602 Tile Floor - Replace****Quantity: Approx 980 square feet**

Evaluation: Your current plans are to replace tile flooring soon but no preliminary bids or specification were provided. Long term planning assumes replacement interval needs with similar as factored below. Clean, seal grout and provide minor repair as operating expenses

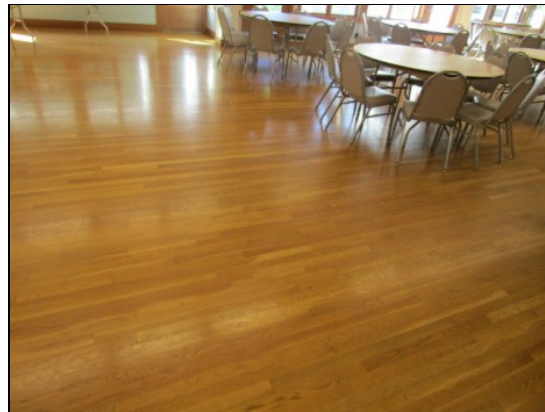
**Comp #: 604 Wood Floor - Replace****Quantity: Approx 3,400 square feet**

Evaluation: Without advanced deterioration at present. Replacement intervals are factored for this high profile area at roughly the time frame below. See next component regarding intervals of refinishing - add that expense for total project cost.

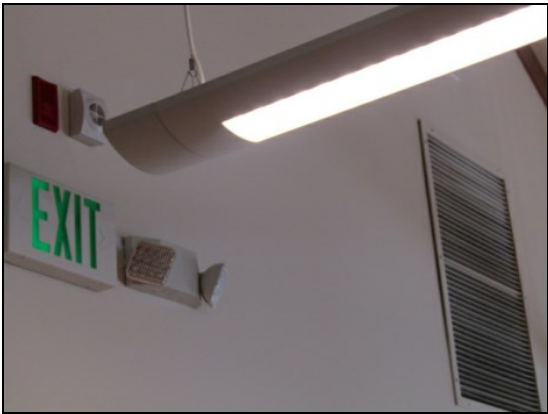
**Comp #: 614 Interior Lights - Replace**

Evaluation: Vary ages and types noted but overall condition is fair. Previous project history reportedly includes replacement of fluorescent fixtures and stage lighting in FY 2008/2009 at an expense of ~\$61,000. Subsequent newer stage lighting reported in FY 2016 at expense of \$5,300; other smaller projects have likely occurred since 1989 as well. No large scale replacements are currently planned for the near term. In our experience, a comprehensive lighting retrofit is warranted at roughly 20-25 year intervals for contemporary functionality, energy efficiency and quality appearance. Plan projects to coincide with interior painting for cost efficiency. Clean, change bulbs regularly and anticipate some local repair/replacement needs periodically as general maintenance expense.

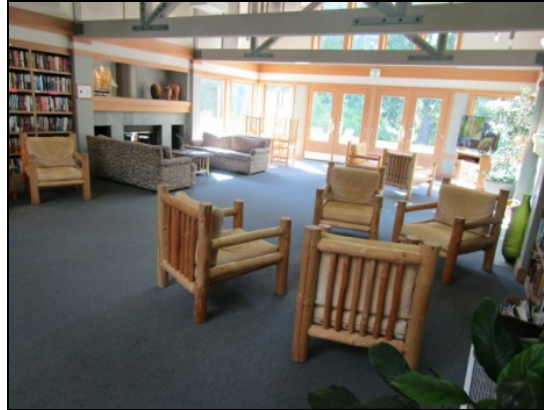
Evaluation: This component recommends setting aside funding for future periodic remodeling and aesthetic updating. Majority of furnishings are older but generally fair and functional; community has benefited from gentle use. It is our understanding that in 2010 banquet tables were replaced at an expense of \$11,000 and also conference room furniture (\$7,000). Research for this update confirmed deferred renovations of great room furnishings are now likely in the near term but no definitive or specific plans have been developed as yet. Extensive redesign (\$100,000 +) is atypical but many communities replace such items as furniture groupings, wall coverings, window treatments, artwork, cabinetry, décor, etc... at regular intervals to maintain these important community areas. Timing and expense by nature are subjective; track desires, needs and expense patterns and adjust in future reserve study updates as conditions warrant.

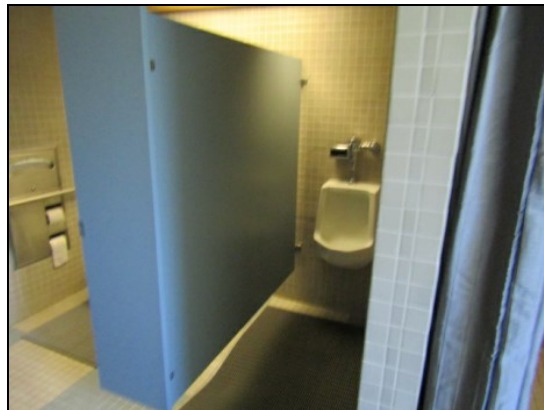
Evaluation: Your current plans for FY 2018/2019 renovation projects are still being developed. Scope may include items such as vanities, showers, lockers, lighting, fixtures, stall partitions, wall tile work, etc... Timing and expense are subjective by nature; adjust funding levels in future reserve updates as conditions merit.

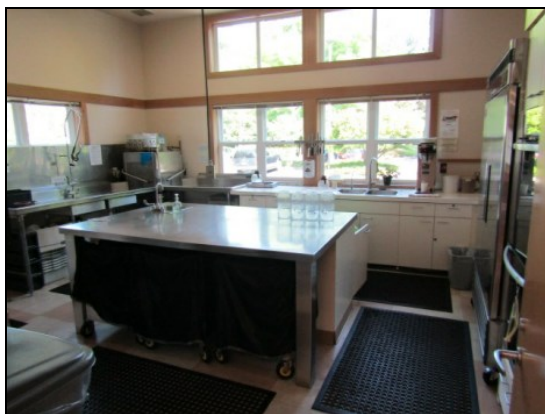
Evaluation: Adequate performance assumed and no significant problems at present. Typical useful life of commercial equipment such as food prep island, cabinetry, counters, etc...is 15-25 years. For now, no specific plans or specifications were expressed so "budget placeholder" for significant, integrated replacements and modest design changes factored below. Adjust in future reserve study updates as conditions merit. See next components regarding major appliances.

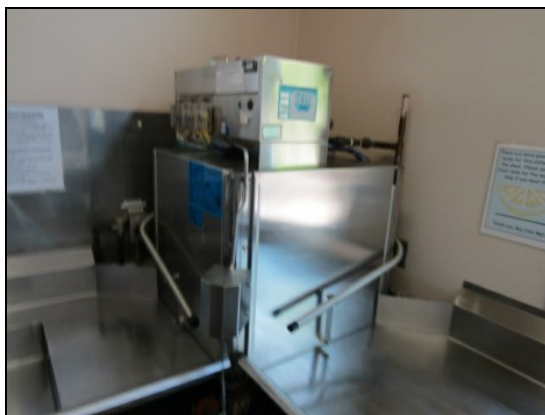
**Comp #: 632 Dishwasher - Replace****Quantity: (1) commercial**

Evaluation: Old commercial equipment is functioning but beyond the typical use life of 20 years (reportedly installed last in 1992). No preliminary bids or plans for FY 2017/2018 replacement; anticipate needs at anytime.

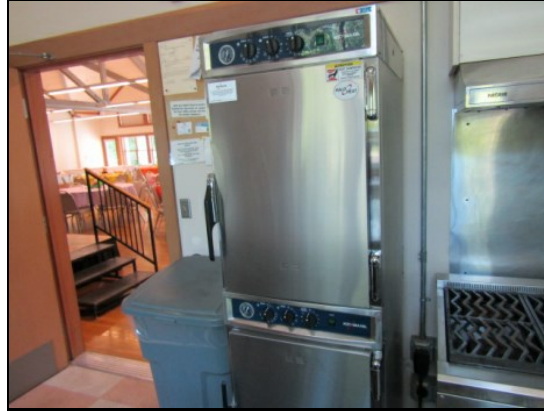
Evaluation: Alto Shaam food warmer was reportedly installed last in 2008. No reported problems; anticipate needs every 15-20 years as factored below.

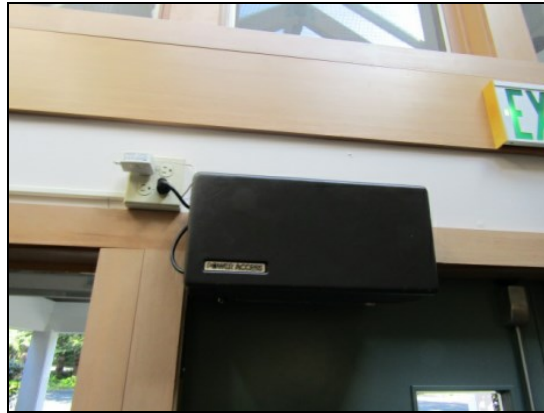
Evaluation: ADA door operators were installed in FY 2010/2011 at both bathrooms and the main entry at a reported expense of only \$3,400. No reported problems or performance issues with existing system. Typical useful life is somewhat driven by usage but assume roughly 10-15 years as projected below.

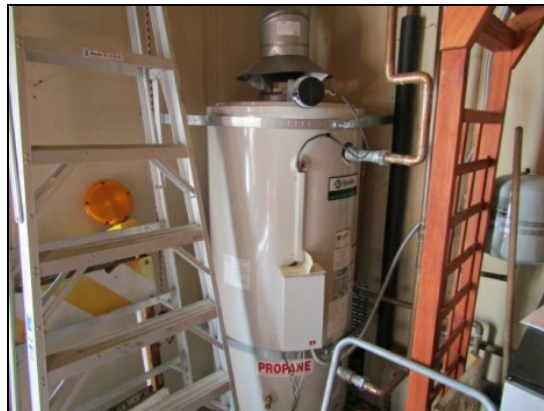
Evaluation: Both units were replaced last in FY 2014/2015 at total expense of \$15,400. Current equipment schedule includes A.O. Smith brand, 65 gallon, 305K BTU input gas unit providing hot water for commercial kitchen. Assumed 50 gallon unit in the attic of the Bay Club was not physically verified. Water heaters (or boilers) are recommended for proactive replacement at the 10-15 year interval. Anticipate such to help prevent water damage incidents and maintain smooth operations.

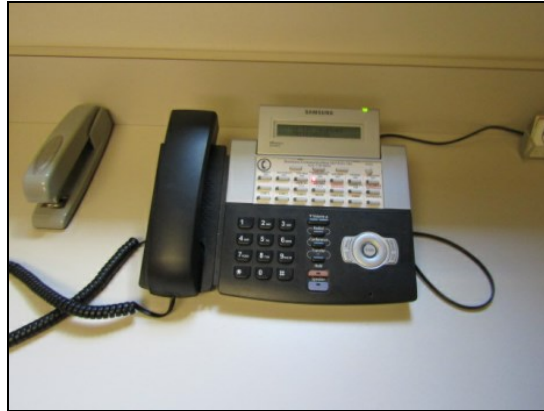
Evaluation: Fair condition; replaced last in FY 2013/2014 at an expense of ~\$3,500. Assume integrated replacement intervals as factored below.

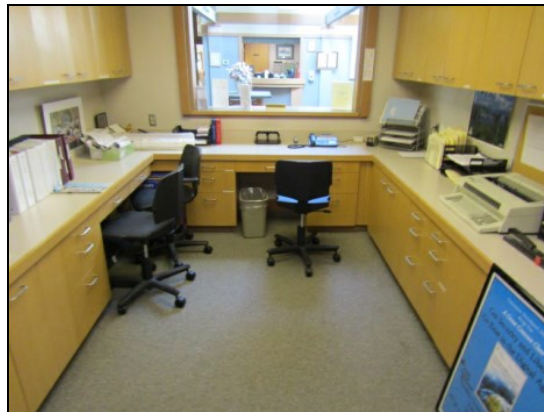
Evaluation: Equipment schedule currently owned includes at least servers, computers, monitors and small printers/all-in-ones. In any event, research with Management confirmed likely needs, expense events as factored below. Track needs, actual expense patterns and adjust in future reserve study updates as conditions warrant.
