## Update "With-Site-Visit" Reserve Study

### **South Bay Community Association Port Ludlow, WA**

**Report #: 23316-2**

**Date Prepared: December 1, 2020**

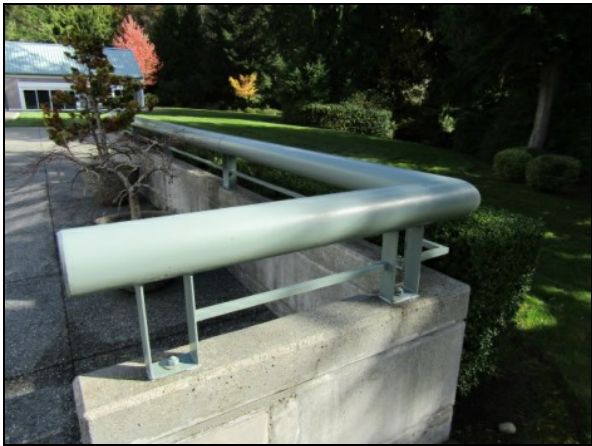
**Comp #: 524 Site Metal Rail - Replace**

Comments: Fair condition without significant corrosion, structural damage or deterioration observed. Minor expense to paint in FY 2017/2018. Sturdy construction that can last for very extended period with ordinary care and maintenance. Inspect regularly for stability and tighten connections, repair promptly as needed to ensure safety. Clean periodically for appearance and paint along with other exterior building surfaces, no need for separate funding. No expectation of large scale replacement within the scope of this reserve study, therefore no reserve funding recommended.

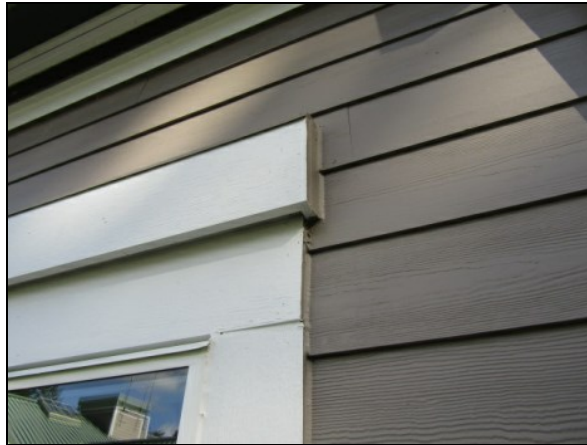
History: Exterior painting was evidently part of FY 2016/2017 ~\$835,000 repairs

Comments: Good to fair condition with ample coverage noted. Exterior painting was evidently part of FY 2016/2017 ~\$835,000 repairs. Segregated expense was reportedly \$48,000. Going forward, we recommend cleaning and refinishing intervals to include all exterior building painted surfaces as appropriate for purposes of long term planning. This approach will ensure cost efficiency, best appearance and weatherproofing performance. We also recommend regular professional inspections with prompt repair and touch-up as needed to ensure that material protection and waterproof integrity of the building is maintained. Typical Northwest paint cycles are between five to ten years depending upon surface preparation, material quality, application methods, site and weather conditions. Maintenance of caulking with high quality product is important part of surface preparation. Repair any siding/trim necessary prior to painting. Anticipate cleaning, sealing and painting utilizing quality materials and workmanship at level indicated below.

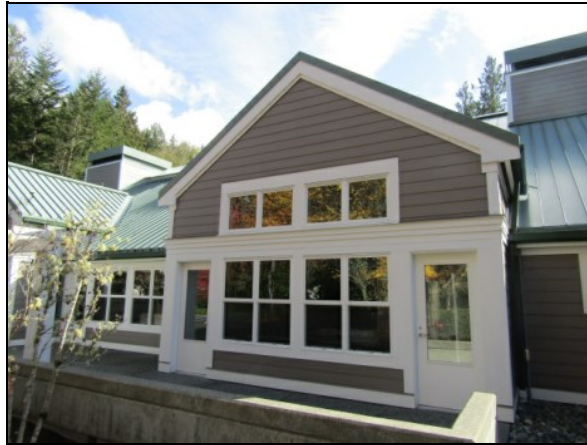
**Comp #: 542 Exterior Siding - Repair/Replace**

Comments: As new condition for Clubhouse exterior cladding (siding); now primarily consisting of cement fiber products.

Replacement was part of FY 2016/2017 ~\$835,000 repairs; we assume proper installation with adequate underlying moisture barrier. Small amount of older wood shingle and assorted trim at Storage Building is still in fair, stable condition. When correctly installed, siding is a durable, long lived product assuming proper care and maintenance (timely cleaning, caulking and refinishing). We recommend regular professional inspections with prompt repair as needed to ensure weather tightness is maintained. For purposes of long term planning, we assume eventual replacement of siding, underlying weatherproofing at roughly 40 years as factored below. Such project is timed to coincide with future clean/paint/seal interval for cost efficiency and quality waterproofing. Note; cost may vary significantly depending upon any underlying structural repair needs.

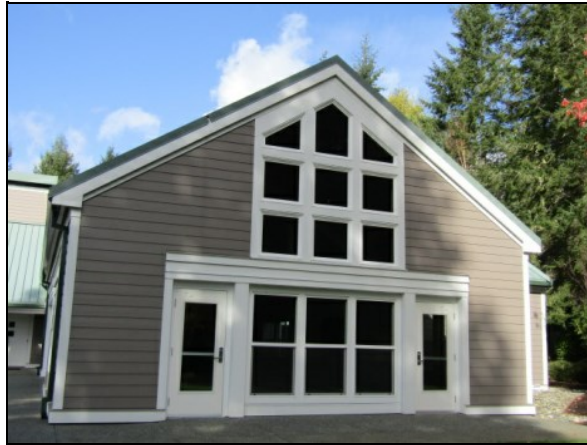
**Comp #: 544 Windows/SGD's - Replace**

Comments: Vast majority are newer; replacement was part of FY 2016/2017 ~\$835,000 repairs. If properly installed without defect, most windows and glass doors have a service life of 20 to 30 years or more. We recommend the Board ensure regular professional inspections of windows and glass doors, penetrations, sealants and adjacent structure by a highly qualified contractor or engineer to assess repair needs and timing to help prevent structural damage to building. Going forward, prudent planning suggests anticipation for eventual window replacement (glass, frames, etc..) during siding replacement project for quality weatherproofing. Adjust funding assumptions in future reserve study updates as conditions dictate (I.e. if patterns of significant and/or more urgent replacement needs become apparent). Carefully track needs and any actual expense patterns to facilitate accurate budget forecasting.

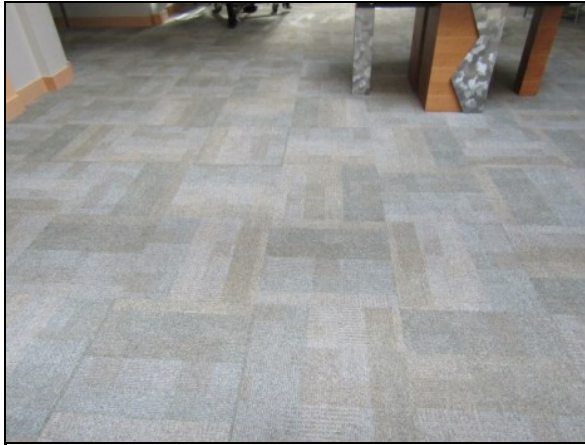
**Comp #: 600 Carpet/Vinyl - Replace****Quantity: Approx 1,200 SY**

Comments: Improved appearance; vast majority of interior flooring is newer carpeting or laminate in good condition. Total expense of ~\$49,600 occurred in FY 2017/2018 and FY 2019/2020 for replacement of assorted carpet at great room, hall, exercise and fitness rooms and GM's office. Also, new laminate noted at craft, card and classrooms along with reception and business office locations. Research indicated previous large scale replacement had occurred in 2004 or perhaps even earlier. A few subsequent and minor local replacements were noted, such as the conference room in 2010. As part of ongoing maintenance program, continue to vacuum carpet and clean as needed. Community benefits from proactive care and gentle use. Timing and expense are somewhat subjective by nature but periodic needs for aesthetic updating are not. For purposes of long term planning and to maintain a quality appearance, we recommend planning for replacement at roughly the 10-12 year time frame below; base year FY 2018/2019.

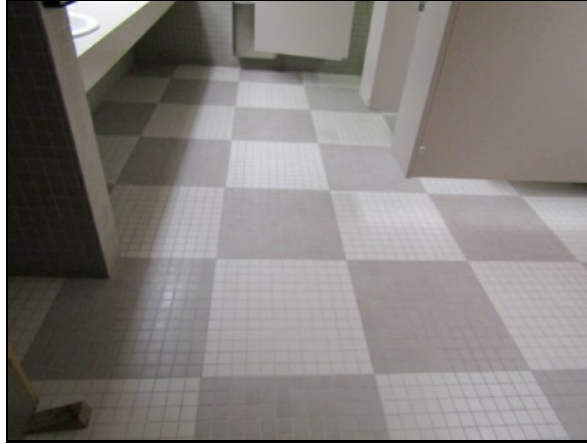
Comments: Older tile floors located in bathrooms and locker rooms are in fair condition. FY 2017/2018 expense of \$5,700 for cleaning/sealing grout. Research informed us that your plans are to maintain but not replace these tile locations. Moving forward, anticipate cleaning tile, seal grout and providing minor repair as reserve component at level indicted below.

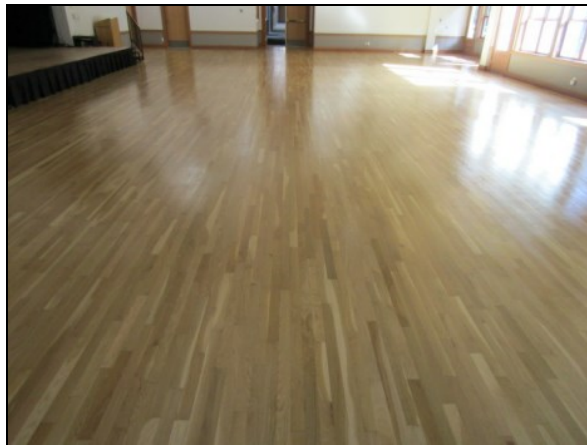
**Comp #: 604 Wood Floor - Replace****Quantity: Approx 3,400 square feet**

Comments: Fair condition without advanced deterioration at present. Eventual replacement intervals for wood flooring are factored for this high profile area at roughly the time frame below. See next component regarding intervals of refinishing - add that expense for total project cost.

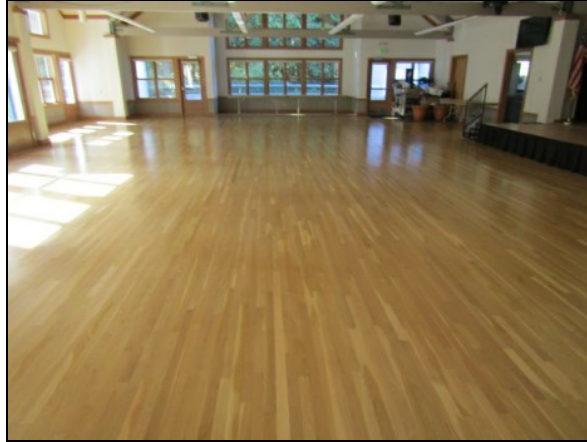
Comments: Good condition of wood finish. FY 2018/2019 expense of \$14,200 for auditorium/stage floor refinish project, then subsequent need in FY 2019/2020 for local refinish again due to tap dance damage. Prior events include auditorium wood floor refinished in FY 2004 at an expense of ~\$12,000. The small stage at some point between 2014 and 2017 at unknown expense. In any event, anticipate future intervals of professional resurfacing of all wood flooring as factored below. If needed, more frequent refinishing of stage should be provided in between from operating funds.

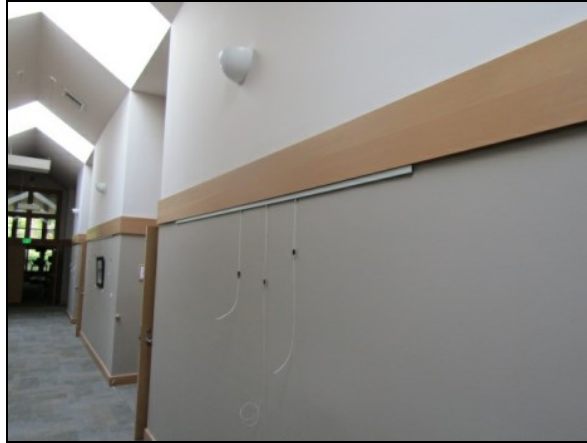
Comments: Condition varies to some degree but overall good condition for most areas. Large scale painting last at total expense of ~\$15,600 in FY 2017/2018 and FY 2019/2020. Prior large scale painting project perhaps occurring last in 2007; definitive timeline or cost history was not provided. Also previous reports that smaller projects, such as exercise room were reportedly painted in FY 2013 and conference room in 2011. Going forward, regular cycles of uniform painting and refinishing of interior ceilings, walls and wood work are recommended to maintain quality appearance; typical useful life cycles are 8-12 years; base year FY 2018/2019. Time projects prior to flooring replacement or refinishing for maximum aesthetic impact, logistics and cost efficiencies. Keep touch-up paint on site for in between cycle projects.

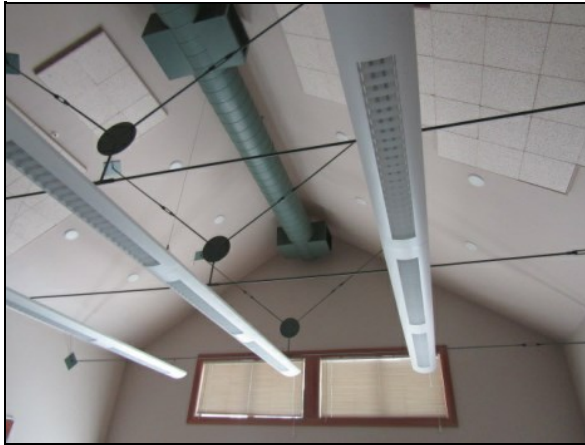
**Comp #: 614 Interior Lights-Partial Replace**

History: Your current FY 2020/2021 plans to replace most bulbs with LED along with some newer fixtures at expense of \$16,600 (after \$2,200 Utility rebate)

Comments: Vary ages and types noted but overall condition is fair. Previous project history reportedly includes replacement of fluorescent fixtures and stage lighting in FY 2008/2009 at an expense of ~\$61,000. Subsequent newer stage lighting reported in FY 2016 at expense of \$5,300; other smaller projects have likely occurred since 1989 as well. Your current FY 2020/2021 plans to replace most bulbs with LED along with some newer fixtures at expense of \$16,600 (after \$2,200 Utility rebate) are factored below. Thereafter, assume interval indicated may suffice going forward. As always, carefully track desires, needs and adjust in future reserve study updates as appropriate. Anticipate some minor, local repair/replacement needs periodically as general maintenance expense.

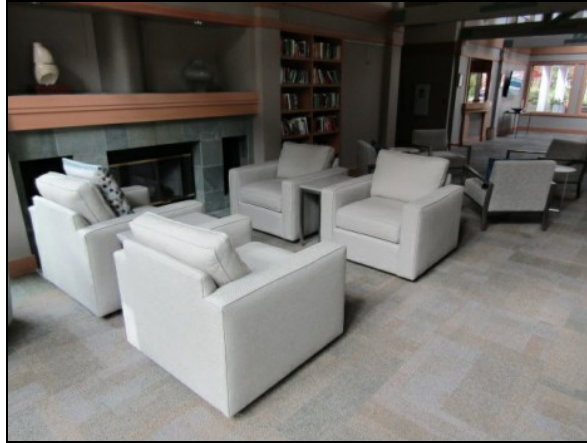
History: Furnishings located in great room were replaced in FY 2017/2018-FY 2018/2019 at an expense of \$33,000.

Comments: Improved appearance since or previous 2017 site inspection. Furnishings located in great room were replaced in FY 2017/2018-FY 2018/2019 at an expense of \$33,000. Previously, 2010 banquet tables were replaced at an expense of \$11,000 and also conference room furniture at \$7,000. Other furnishings are largely older. This component recommends setting aside some funding for future periodic remodeling and aesthetic updating. Extensive redesign (\$100,000 +) is atypical but many communities replace such items as furniture groupings, wall coverings, window treatments, artwork, cabinetry, décor, etc... at regular intervals to maintain these important community areas. Timing and expense by nature are subjective; track desires, needs and expense patterns and adjust in future reserve study updates as conditions warrant. Base year FY 2018/2019.

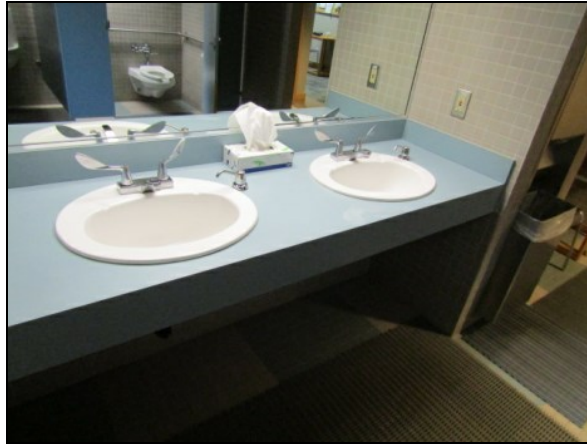
Comments: Clean and without damage but overall older amenities. Your previous plans for FY 2018/2019 renovation projects were apparently deferred. No significant changes observed and we were informed that renovation plans are still being developed and may occur next in FY 2025/2026. Scope may include items such as vanities, showers, lockers, lighting, fixtures, stall partitions, wall tile work, etc... Timing and expense are subjective by nature; adjust funding levels in future reserve updates as conditions merit.

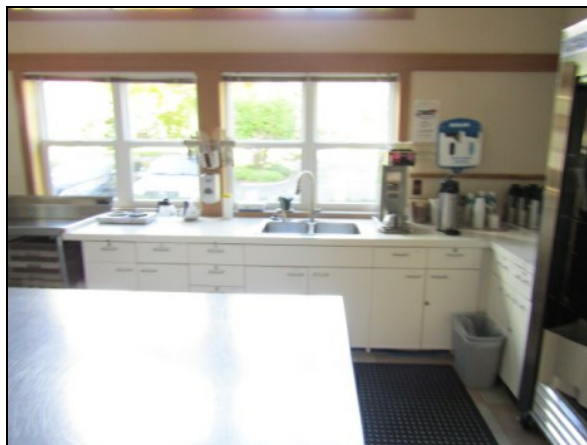
Comments: Fair condition; adequate performance assumed and no significant problems at present. Typical useful life of commercial equipment such as food prep island, cabinetry, counters, etc...is 15-25 years. For now, no specific plans or specifications were expressed so "budget placeholder" for significant, integrated replacements and modest design changes factored below. Adjust in future reserve study updates as project gets closer, conditions merit. See next components regarding major appliances.

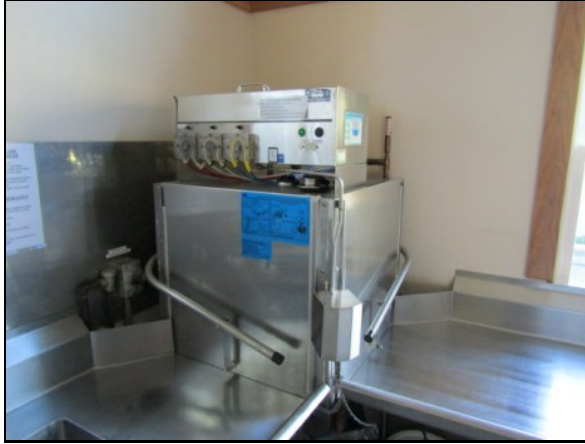
**Comp #: 632 Dishwasher - Replace****Quantity: (1) commercial**

Comments: Old commercial equipment is assumed functioning but well beyond the typical use life of 20 years (reportedly installed last in 1992). No preliminary bids or current plans for FY 2020/2021 replacement. Regardless of current non-use during global pandemic anticipate needs at anytime due to age of equipment and for purposes of long term budgeting.

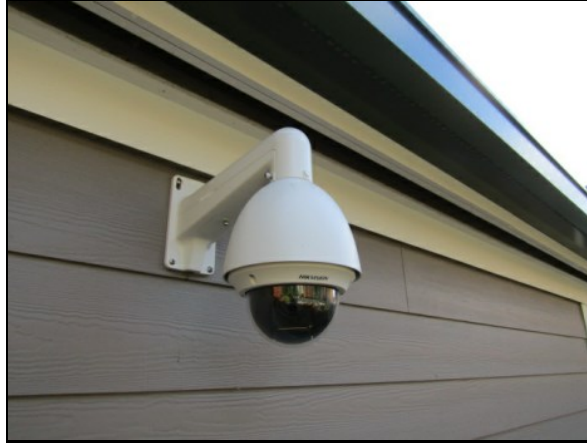
Comments: Provided financial details indicate installation of three new exterior HD cameras with panning capability in FY 2018/2019 at a expense of \$4,300. Moving forward, future intervals of replacement at roughly the 8-12 year interval are factored below.

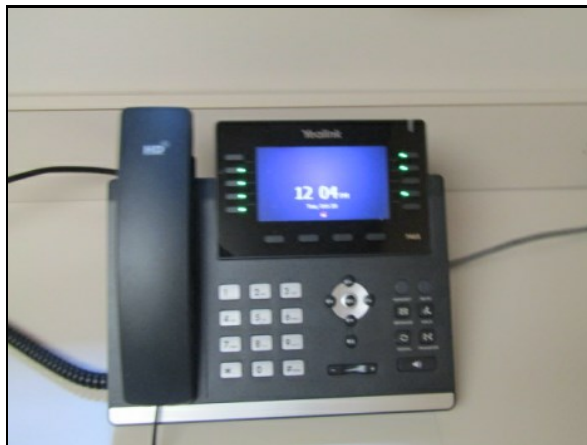
Comments: Good condition; replaced last in FY 2018/2019 at an expense of \$3,500. Previous event in FY 2013/2014 at similar cost (~\$3,500). Assume integrated replacement intervals, as factored below, will continue.

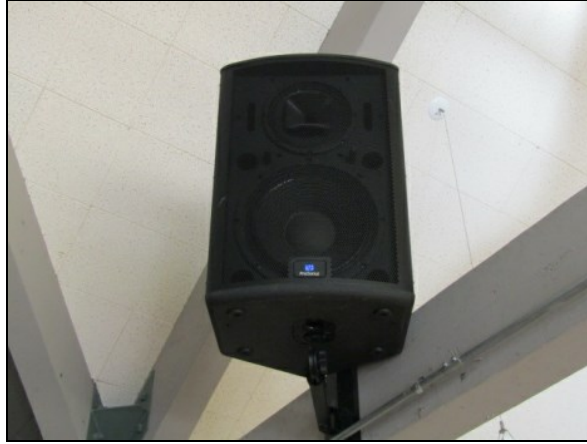
Comments: Auditorium sound system was reportedly replaced in FY 2018/2019 at total expense of \$8,000. It is our understanding that expense was shared equally between SBCA and PLAP at that time. For now, we assume similar arrangement for future replacement events. Track expense history carefully; adjust in future reserve study updates as conditions merit.
